# San Fernando, California, Earthquake of February 9, 1971

LEONARD M. MURPHY  
*Scientific Coordinator*

*Volume I*

*Part B.* Buildings *continued*; Soils and Foundations

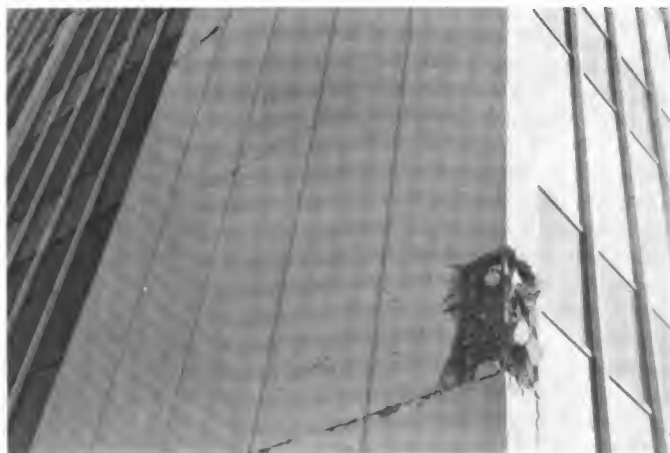
Some of the shear walls were damaged by cracks at the horizontal construction joints at floorlines (figs. 10 and 11). There is evidence of slight horizontal movement. These cracks are not related directly to shear as a measure of diagonal tension. The slab depth is 6½ inches thick, and, in some cases, cracks occurred at the top and bottom of this intrusion of 3,000 psi lightweight concrete into the higher strength rock concrete of the shear walls proper.

The ends of the shear walls were designed as columns and were subjected to shear and axial load stresses. Concrete in the splice area crumbled (fig. 11). All of the shear walls in the lower levels cracked in the typical X-pattern (figs. 10 through 14), indicating high shear stresses.

Figure 11.—Indian Hills Medical Center.  
North-side shear wall, west end.

3 Spalling and crushing occurred in lap-splice areas of vertical rebars in columns. Special ties at these locations should be considered. The whole question of confinement of concrete by ties at compression and tension splices needs further study. Similarly, damage to boundary elements of shear walls in tension casts some question on the lap-splice criteria used, particularly where seismic forces are to be resisted. Does confinement offer the practical solution to this? Perhaps boundary elements of shear walls, at least at splices, should have confining reinforcement similar to that now recommended for ductile columns, or possibly always should be designed as tension splices.

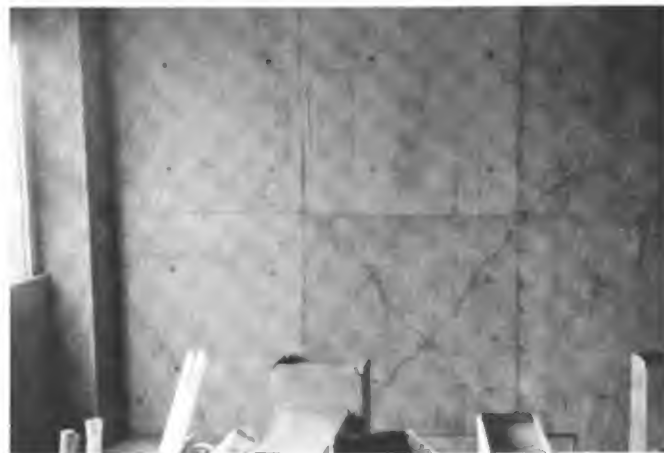
Figure 13.—Indian Hills Medical Center. Shear wall  
X-cracking, third floor.

The typical X-cracking in shear walls was in the east and west shear walls of the north elevation below the fifth floor, as well as in the center shear walls of the east and west elevations below the fifth floor. On the south elevation, diagonal X-cracks occurred only below the fourth floor. The X-cracking produced fairly uniform crack widths in both north-south and east-west walls. The location of this more pronounced X-cracking in the lower floors indicates that the building accelerations were, in general, in the first mode.

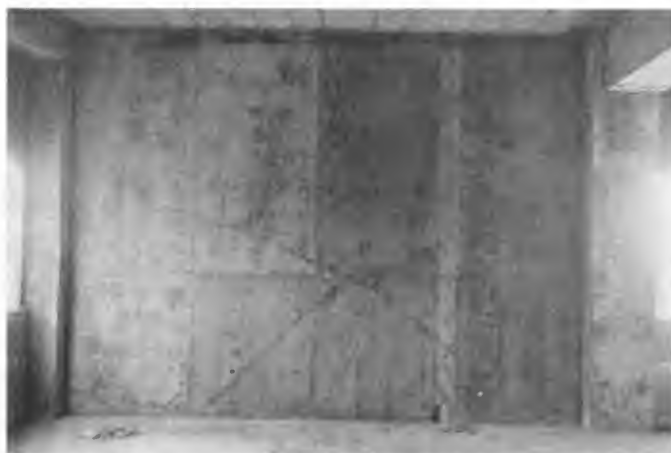
*Figure 14.—Indian Hills Medical Center. Shear wall X-cracking, fourth floor.*

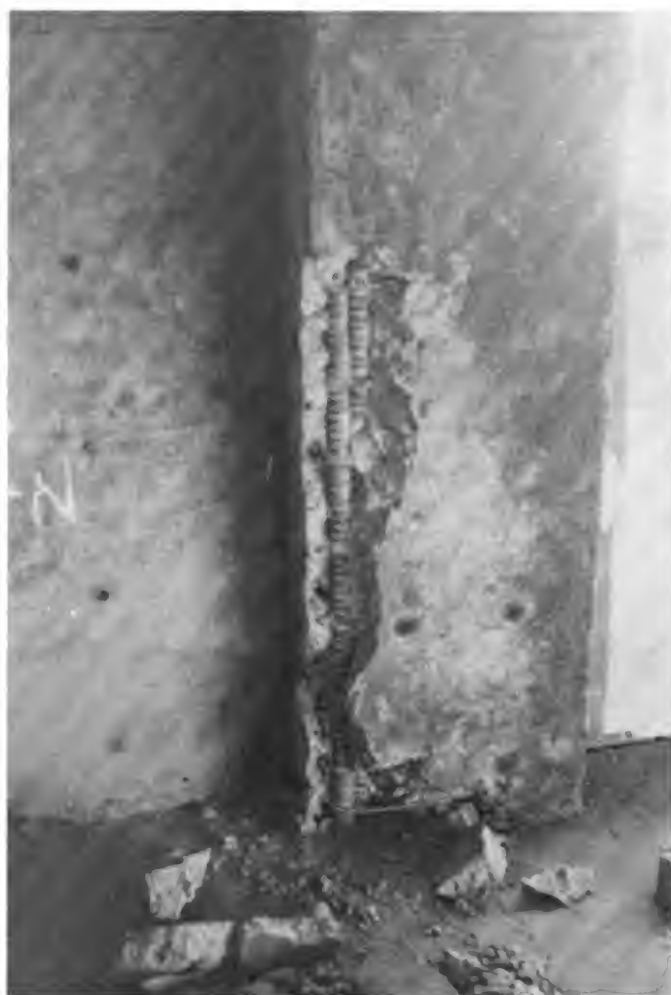
*Figure 15.—Indian Hills Medical Center. Third-floor exterior column damage.*

In several cases where shear walls were tied into the building proper by concrete girders having a significant moment of inertia, damage was noted at the intersection of girder and wall (figs. 15 and 16). The girders run in a north-south direction. Damage was noted where considerable restraint in bending was offered by the girders (fig. 17). However, in at least one case, damage was found in an interior column-girder connection (fig. 18). The 6½-inch-thick floor slab usually is considered a rather stiff diaphragm. Some yield or inelastic deformation must have occurred, either in the diaphragm and/or the walls, to allow the interior beam-column connection to become damaged. The distribution of this type of damage indicates that the failure of the splicing of shear wall end reinforcing was the principal reason for this inelastic deformation, even though there was some cracking in the floor slabs.

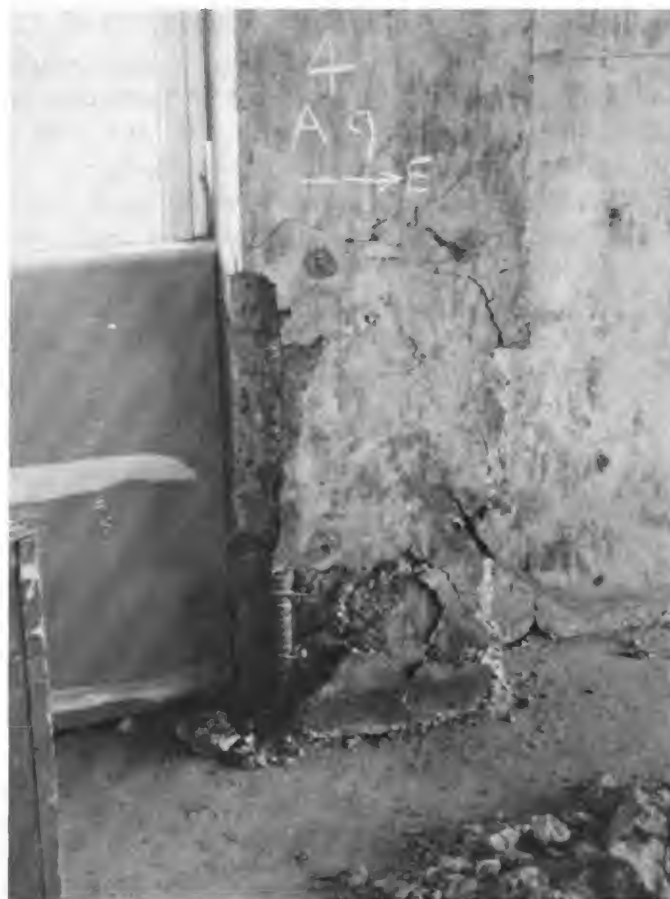
*Figure 16.—Indian Hills Medical Center. Fourth-floor exterior column damage.*

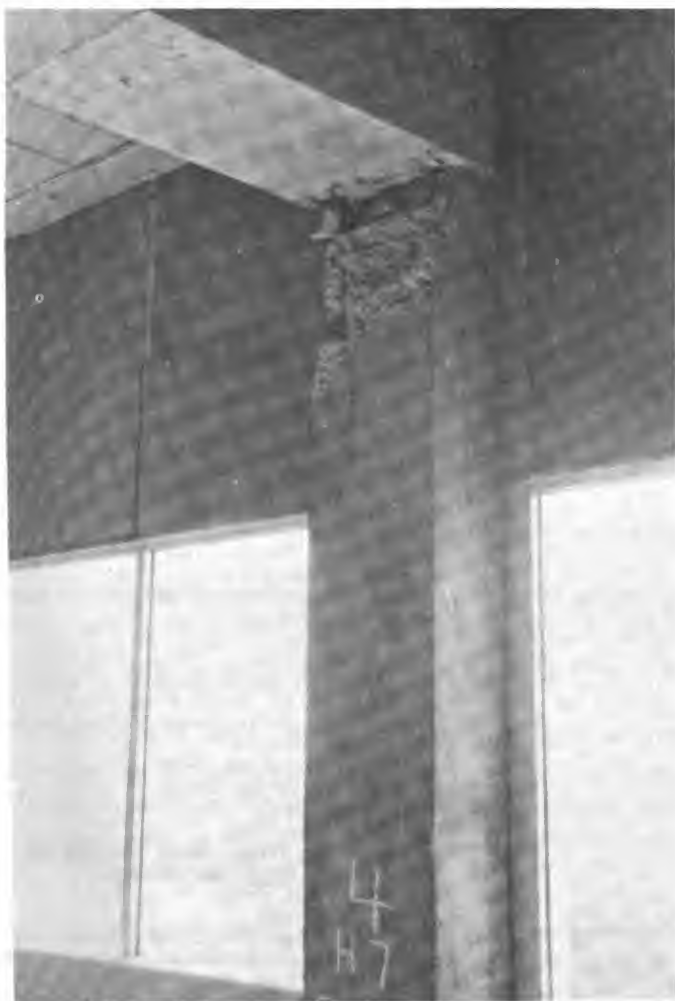
Figure 17.—Indian Hills Medical Center. Fourth-floor exterior girder and column damage.

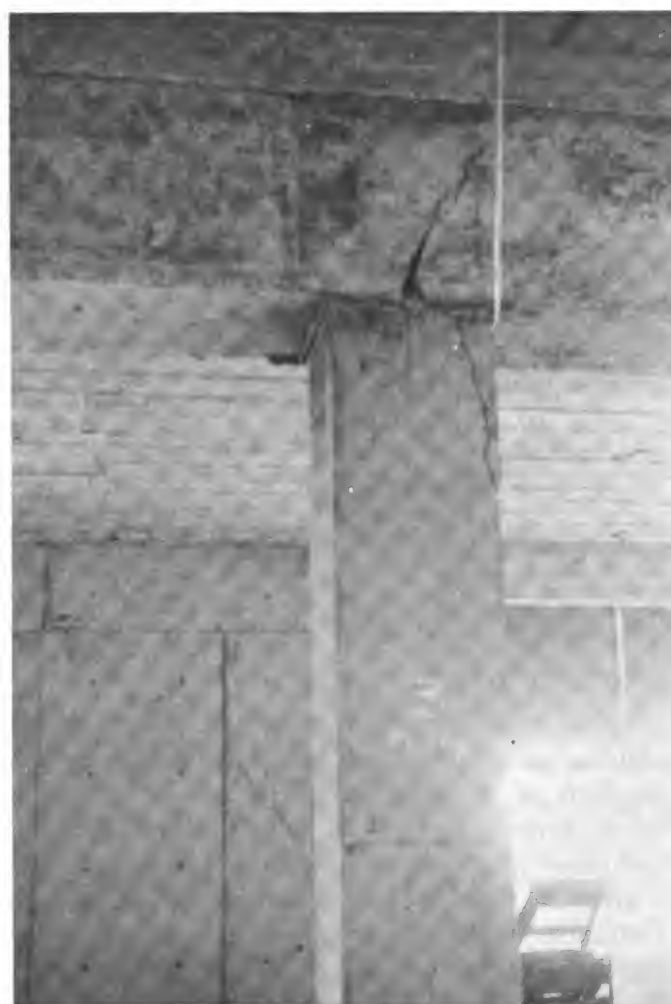
Figure 18.—Indian Hills Medical Center. Third-floor interior girder and column damage.

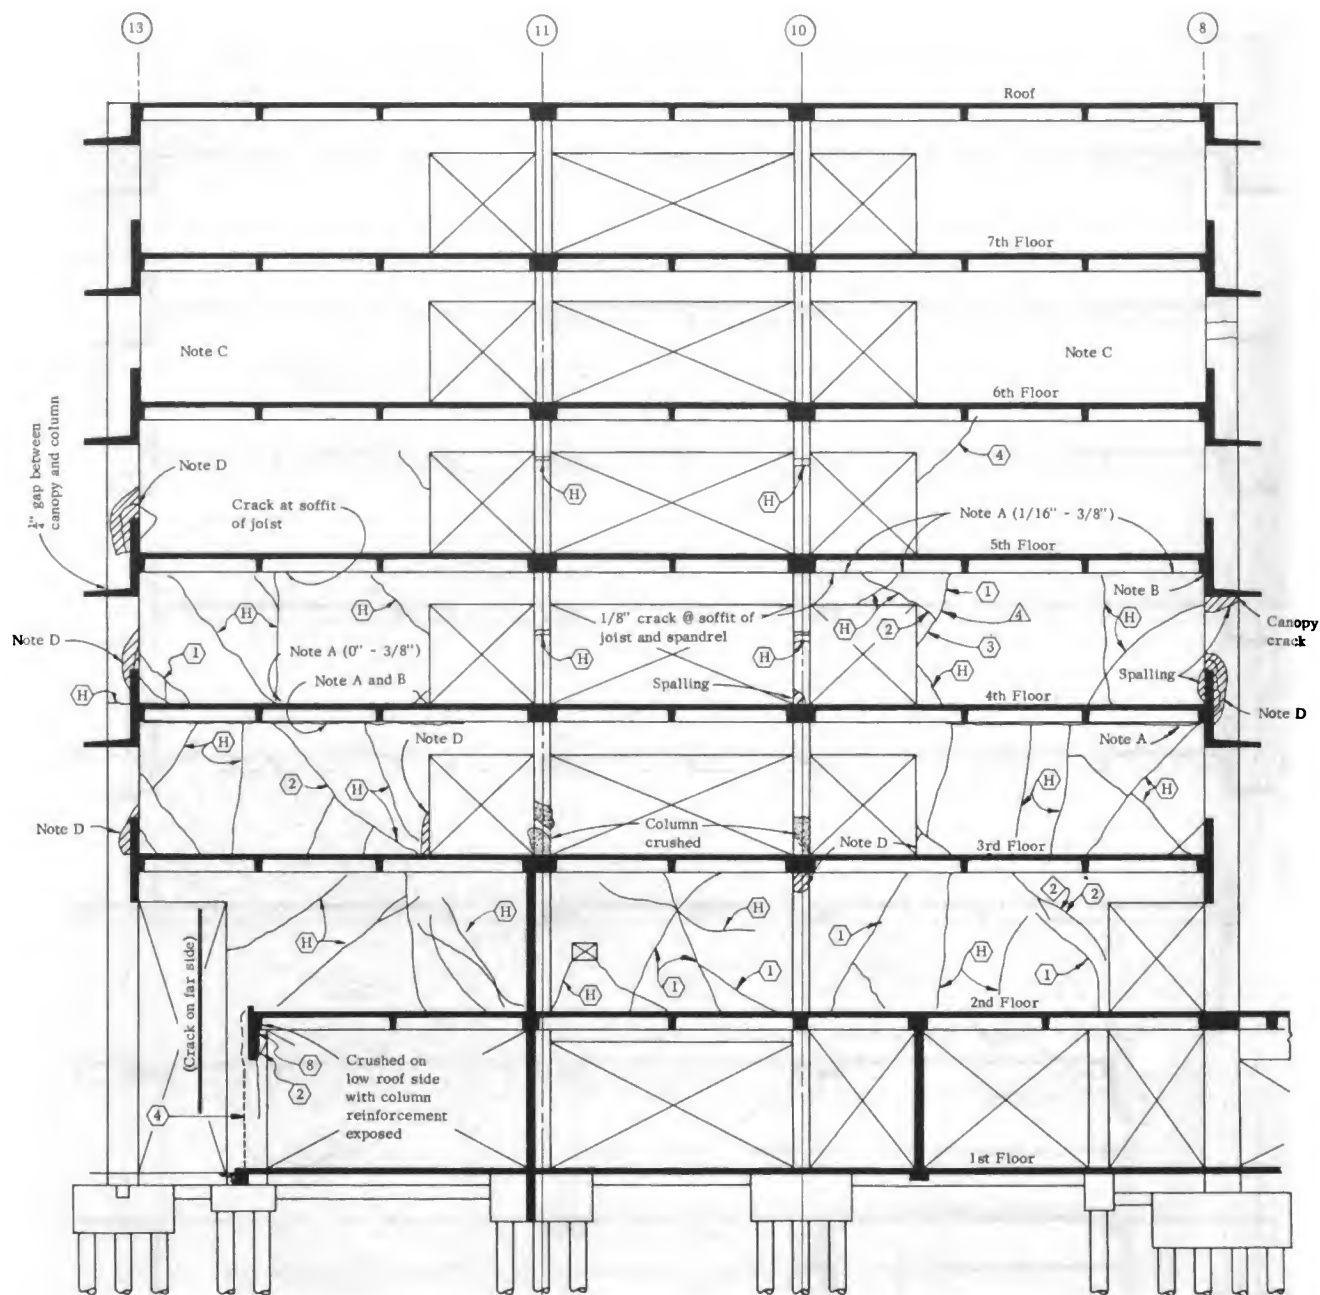
Figure 16.—Holy Cross Hospital. Section at grid line E (west wall, 7-story tower).

- 1 The west shear walls (figs. 16 and 17) were discontinuous below the second floor. The diaphragms

were inadequate to redistribute horizontal loads on the second, third, and fourth floors, and were damaged severely in this area as indicated by cracks extending across the full width of the building (fig. 18).

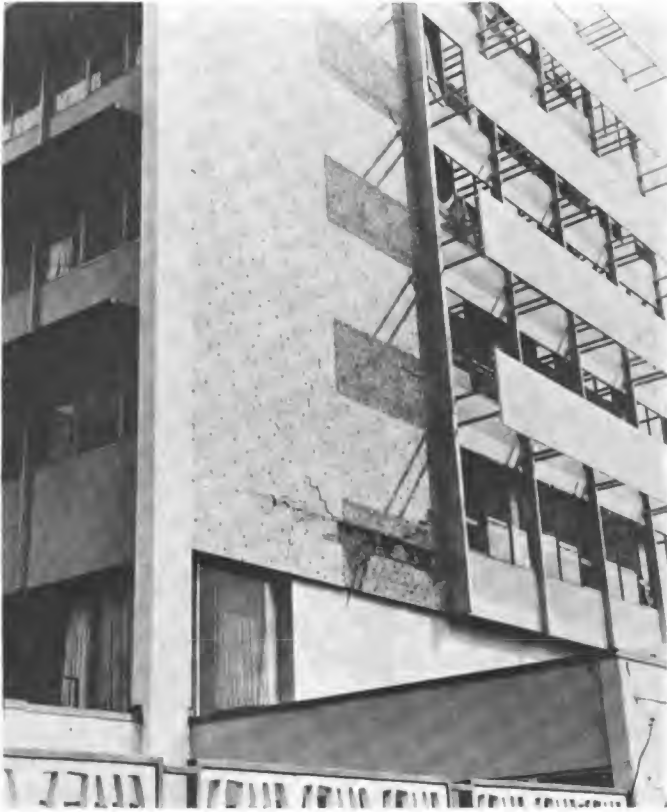
Figure 17.—Holy Cross Hospital, west wall.

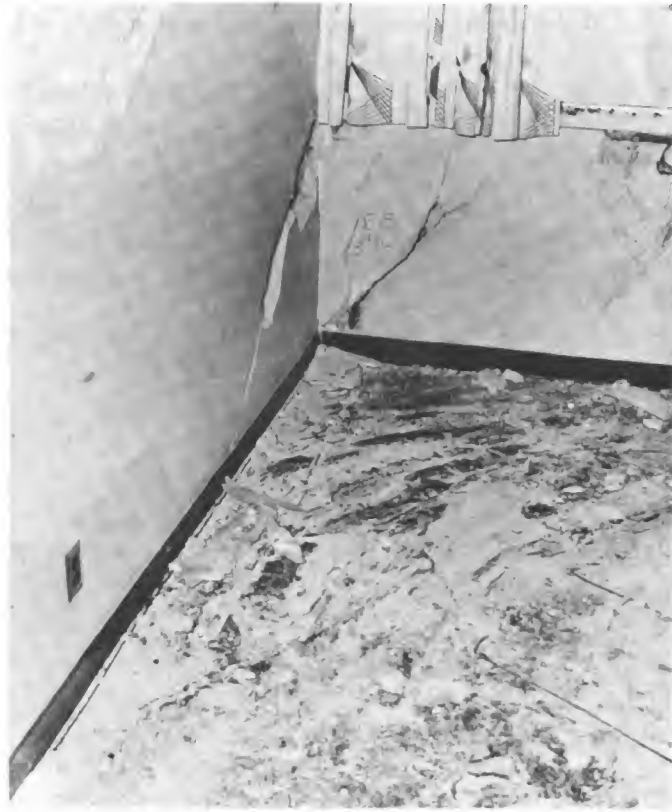
Figure 18.—Holy Cross Hospital. Diaphragm failure at west wall.

The failure of the diaphragm adjacent to the west wall of the tower (see cracked area on fig. 6 near line E) is pointed out by the margin of safety of 1.0 indicated for the third floor. The failure of the diaphragm at this point could have been a contributing factor in the west shear wall failure, by forcing a redistribution of reactions to the wall.

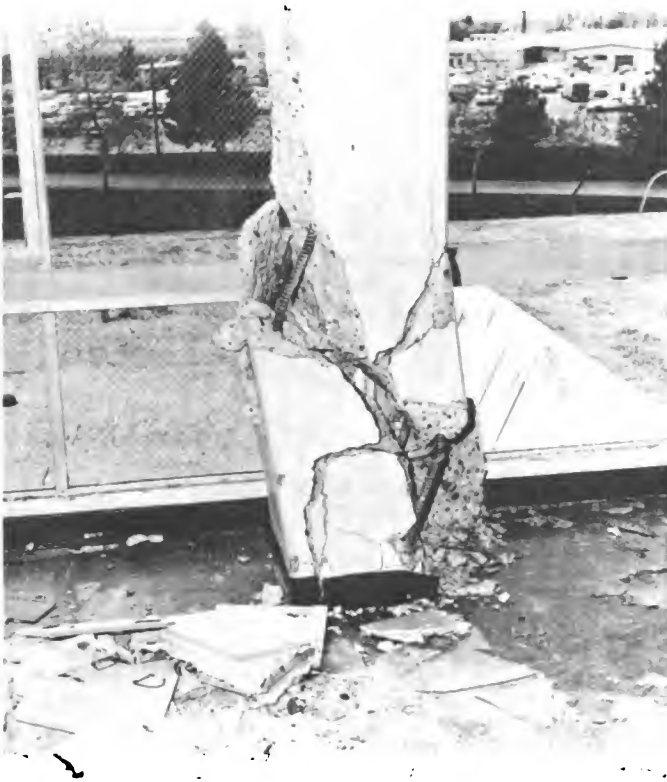
*Figure 19.—Holy Cross Hospital. Column failure at E-11 (third floor).*

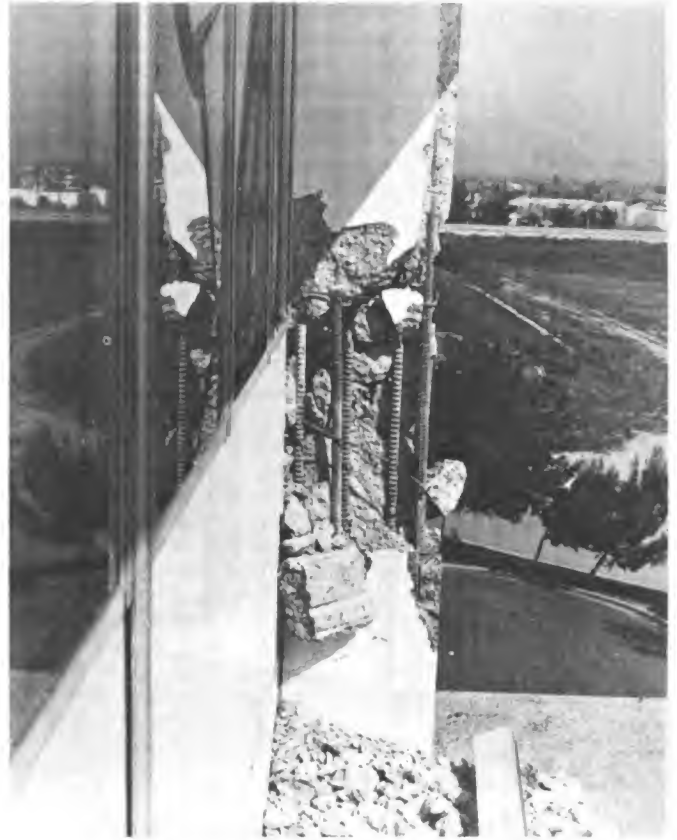
*Figure 21.—Holy Cross Hospital. Shear wall column, southeast corner.*

The east wall column and shear wall failure (figs. 15 and 21) is not pointed out by the analysis. The point of failure occurring at the point of splicing of the column bars on line 13 made this location an obvious weak point in the wall. The tower in the north-south direction did not have as many elements that would crack progressively as it did in the east-west direction. Also, the ground accelerations were obviously high enough to exceed the capacities of the walls.

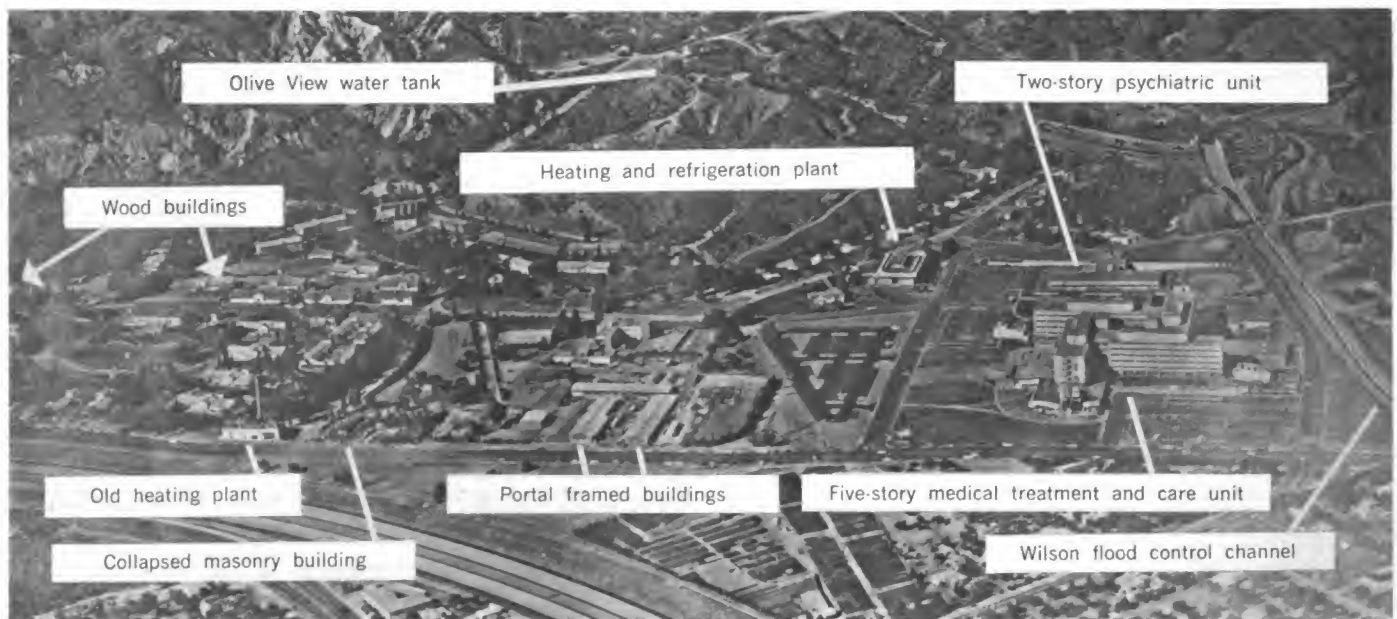
Figure 1.—Olive View Hospital complex, looking north. Old complex is to left and new complex to right. California Institute of Technology photograph.

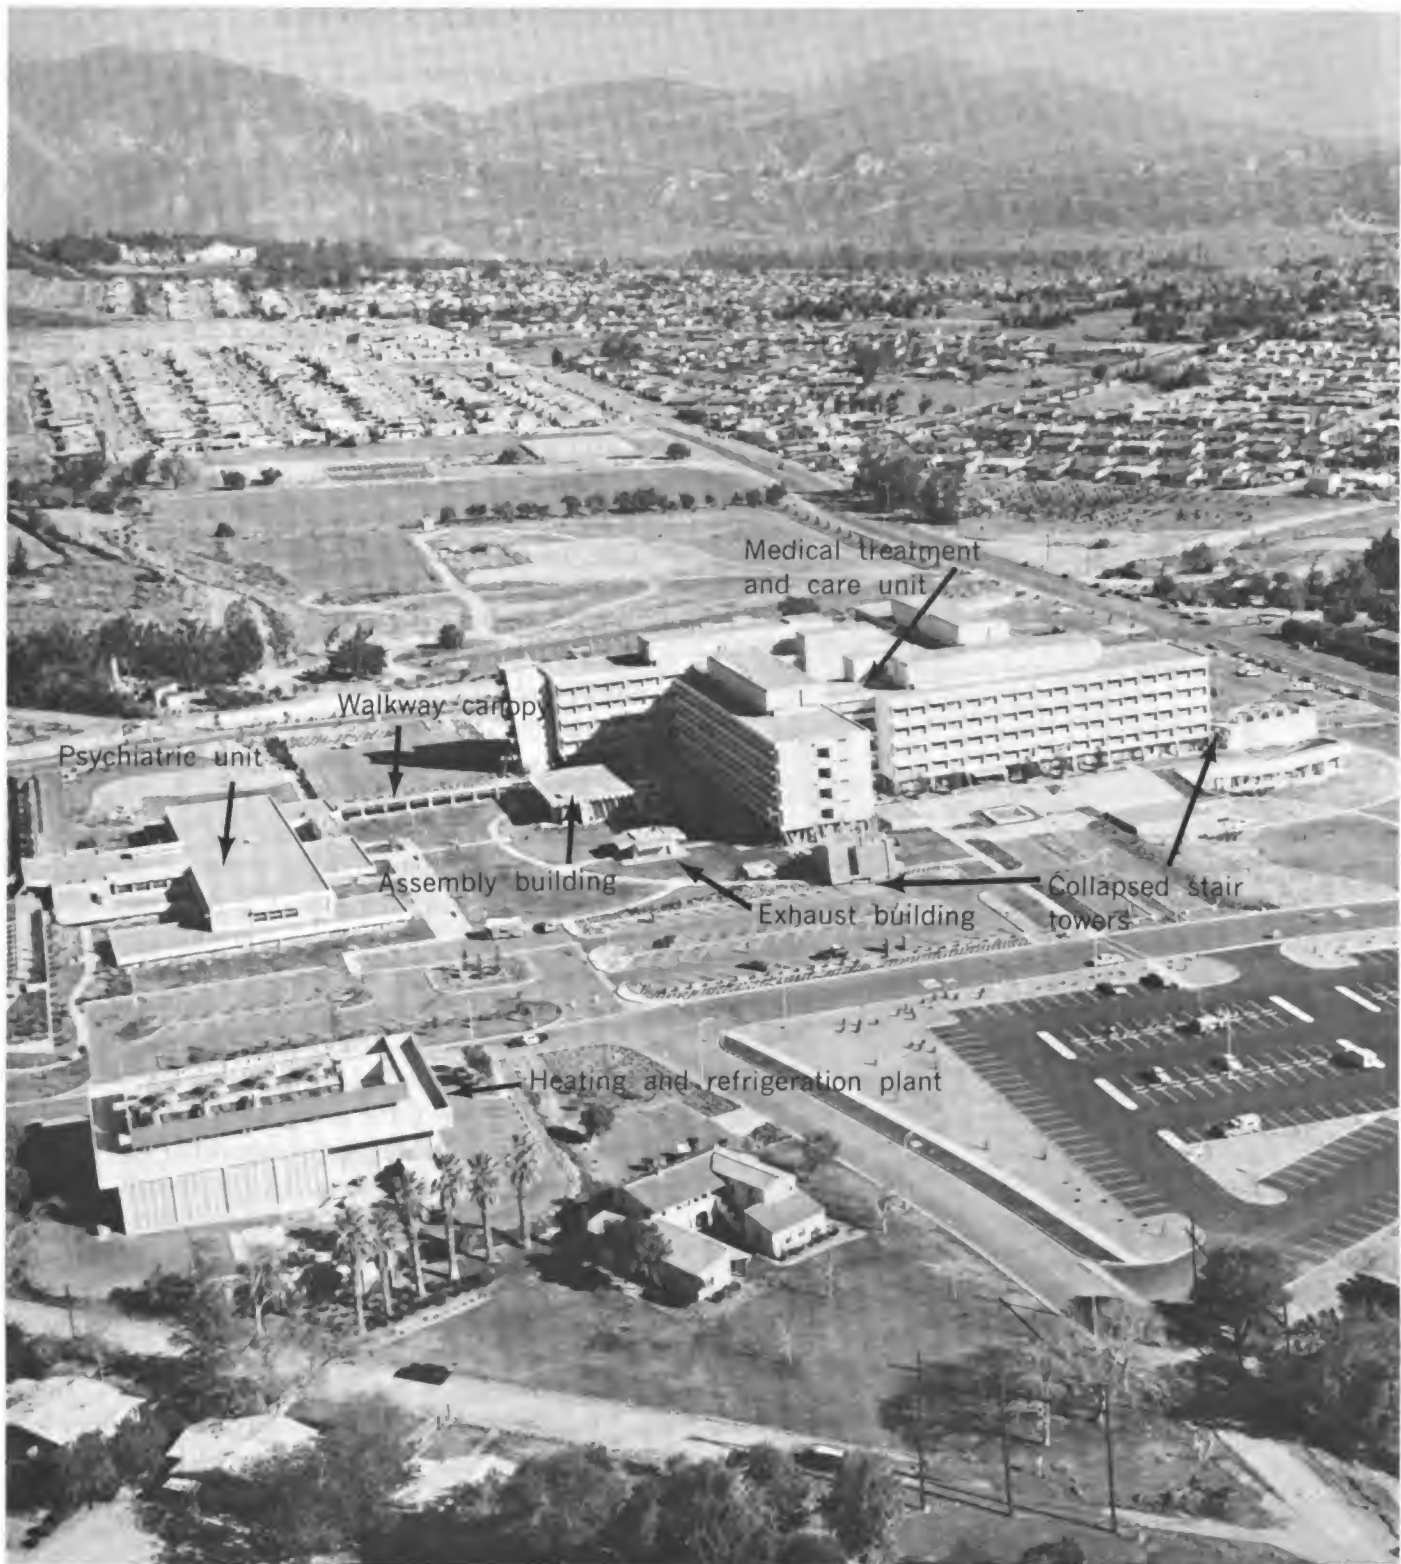
Figure 2.—Olive View Hospital. New hospital complex, looking east. Note overturned stair towers at center and right. Los Angeles City Fire Department photograph.

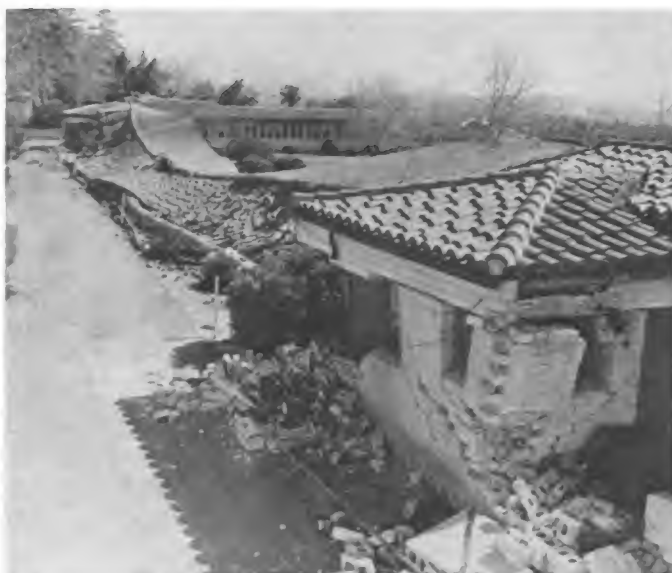
Figure 3.—Olive View Hospital. Collapse of old portion of hospital convalescent wings. These buildings were not designed for lateral loads. U.S. Army Corps of Engineers photograph.

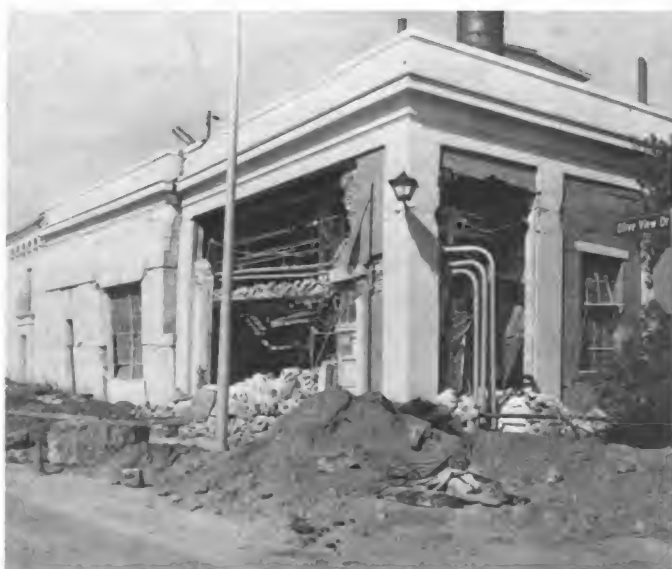
The hospital complex (figs. 1 and 2) consists of many buildings. The older structures were constructed primarily of wood frame and unreinforced brick and hollow tile masonry. Because they were built prior to 1934, they were not designed to resist seismic forces, and many either suffered considerable damage and subsequently were demolished, or collapsed (fig. 3) and were removed later. For example, the original powerplant, built with a reinforced concrete frame and unreinforced brick masonry filler walls, was damaged beyond repair (fig. 4) and has

Figure 4.—Olive View Hospital. Damage to old powerplant of hospital. This building was not designed for lateral loads. U.S. Army Corps of Engineers photograph.

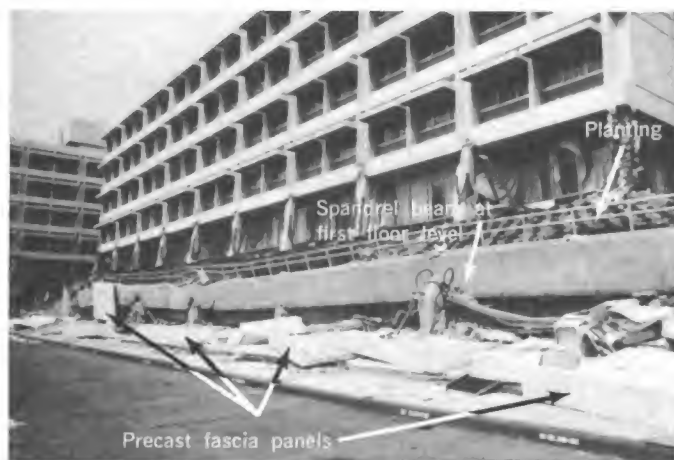
The most obvious distress observed is the distortion in the column from the first to the second floor (figs. 12, 13, and 14). This displacement in a clear height of 14 feet is at the northwest corner, 28 inches toward the north and 15 inches toward the east; at the northeast corner, 15 inches toward the

Figure 12.—Olive View Hospital, medical treatment and care unit. View of south side, looking west, from ground-floor level. Note collapsed ground-floor roof, which is covered by planting, and loss of precast fascia panels from roof spandrel.

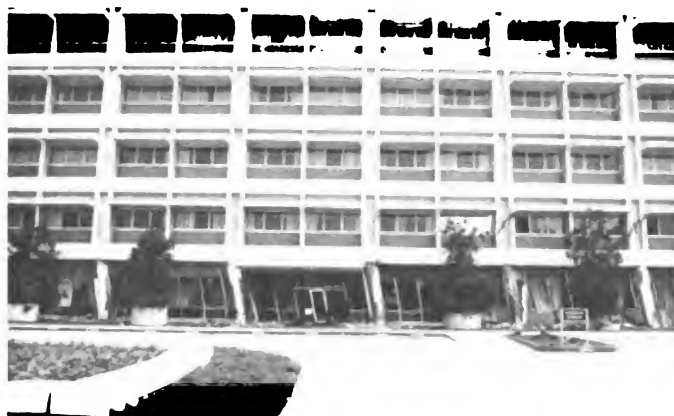
Figure 13.—Olive View Hospital, medical treatment and care unit. View of west side at main entrance from first-floor level.

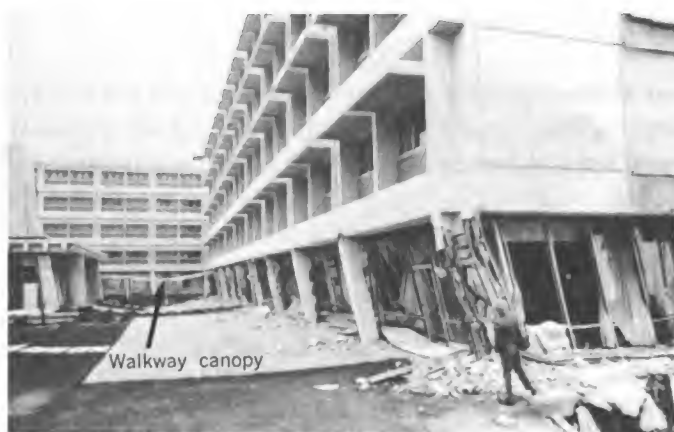
Figure 14.—Olive View Hospital, medical treatment and care unit. View of north side, looking east, from first-floor level. Floor slope is result of collapsed columns below and is emphasized by walkway canopy in background.

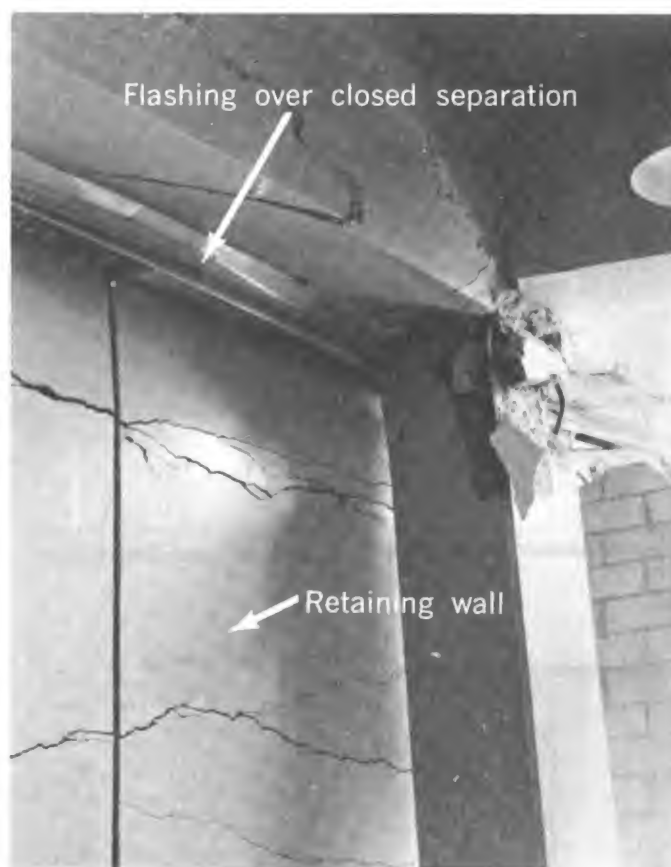
the building moved, closing the minimal 4-inch separation between the resisting frames and the retaining walls, there was an uncalculated, yet effective, resistance developed by these walls. The pounding of the structure against these walls not only disturbed the soil behind the wall, but also caused tension cracks on the inside face (compression side) of the cantilever retaining walls (figs. 15 and 16). It is estimated

Figure 15.—Olive View Hospital, medical treatment and care unit. Horizontal cracks in north basement wall in ground-floor story. Note closure of separation at top of wall.

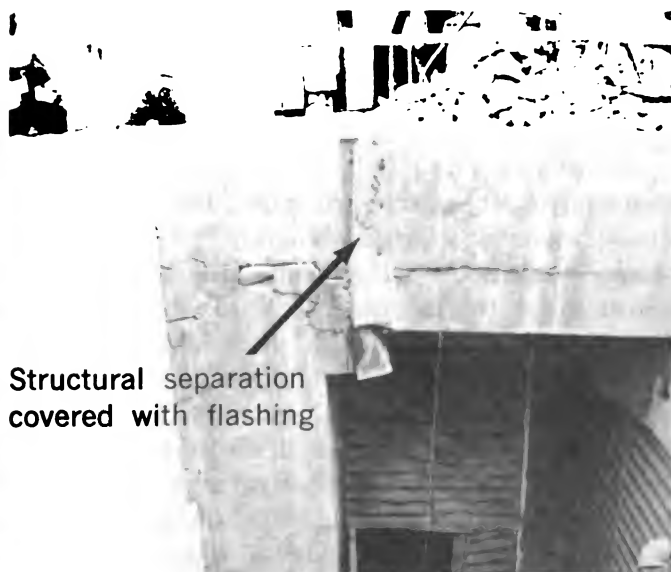
Figure 16.—Olive View Hospital, medical treatment and care unit. Areaway pier at northeast wing, showing effects of hammering by first-floor framing through wall separation.

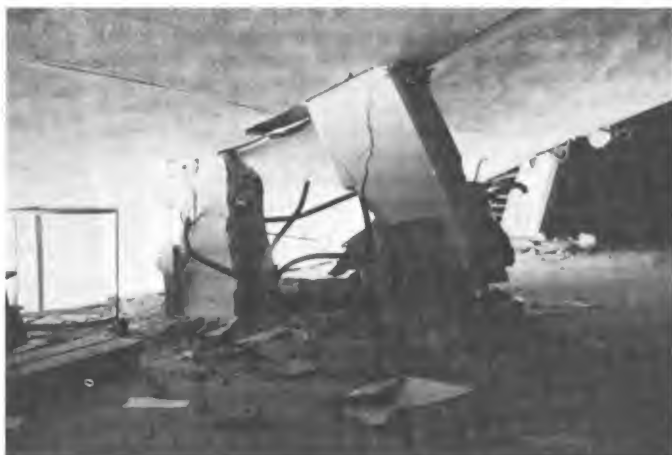
There was failure of all of the tied columns located principally in the base structure (fig. 17) outside the area supporting the four five-story towers.

Figure 17.—Olive View Hospital, medical treatment and care unit. Complete collapse of tied column located at ground-floor level loading dock at east side.

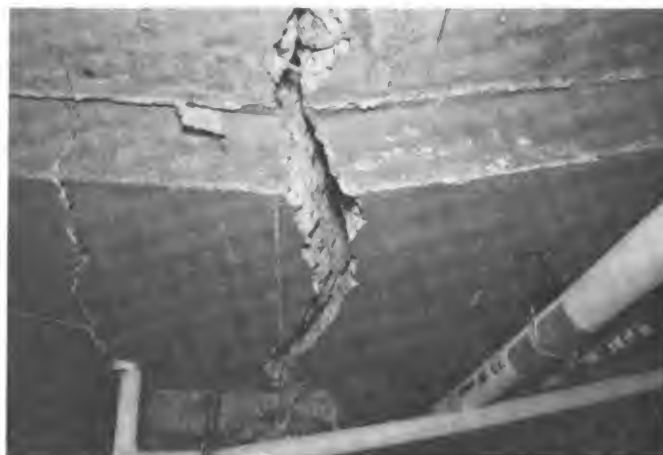
umns located in the pipe space near the north basement wall failed (fig. 18); a continuous crack extending east and west occurred in the ground-floor flat slab (fig. 19); a similar-type crack in the beam and slab framing of the first floor also was apparent (figs. 20 and 21). It was evident that all of these members had been subjected to very high shear stresses, and that either the reinforcing steel was insufficient to resist the magnitude of the forces or the reinforcing steel was mislocated or ineffectively spaced to withstand the unpredictable forces generated in the continuous framing. Further evidence of this type of damage occurred in the flat slab drop panels at the column supports. The cracking and spalling of the

Figure 20.—Olive View Hospital, medical treatment and care unit. Closeup view of figure 19, showing lack of bottom reinforcing bars through crack.

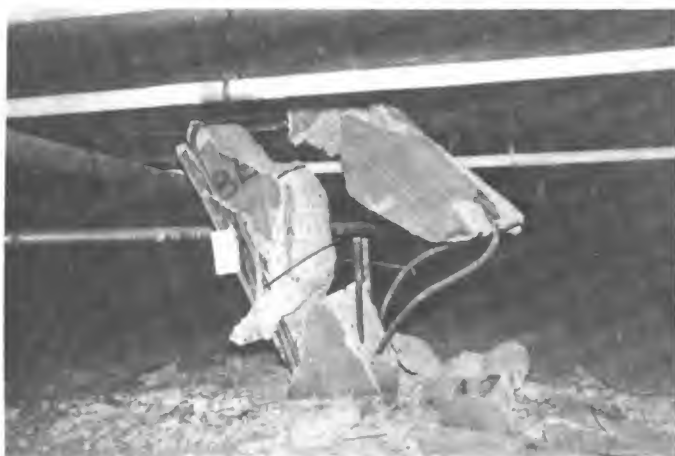
Figure 18.—Olive View Hospital, medical treatment and care unit. Complete collapse of tied column located in pipe space area near north wall.

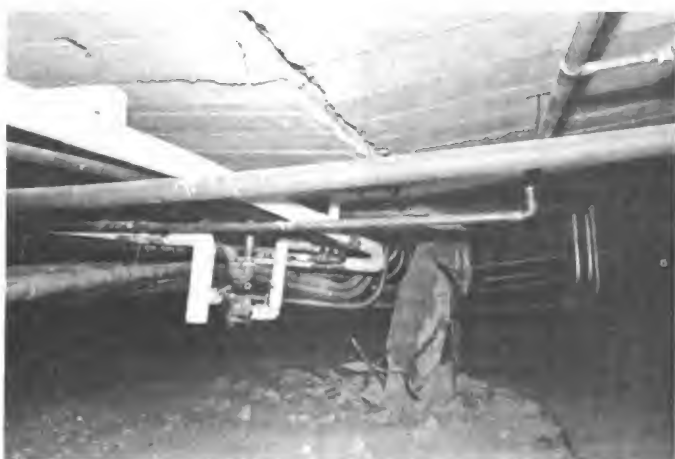
Figure 19.—Olive View Hospital, medical treatment and care unit. Continuous crack formed in underside of ground-floor framing near north wall. Crack is result of collapse of tied columns.

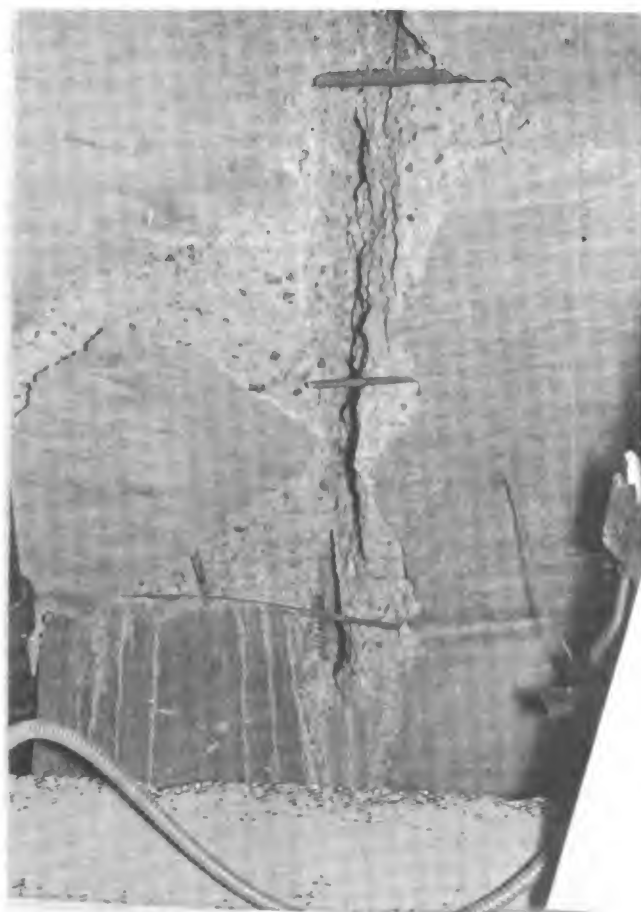
Figure 21.—Olive View Hospital, medical treatment and care unit. Crack formed under first floor framing near a column near the north wall, where column has collapsed below in pipe space.

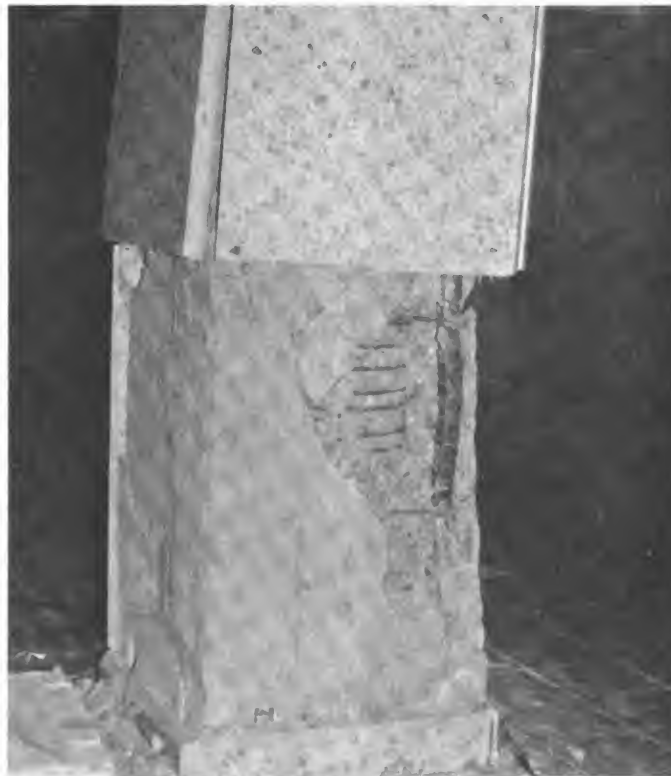
concrete (figs. 22 and 23) are also quite general throughout the first and second floors.

Figure 23.—Olive View Hospital, medical treatment and care unit. Distortion of column (shown in fig. 22) at first floor.

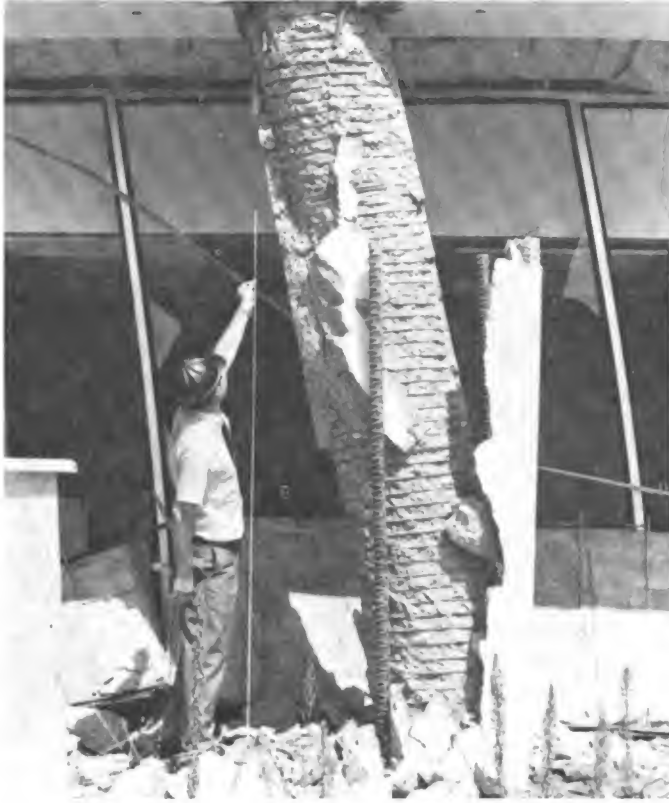
characteristics also were present in the columns with closely spaced spiral reinforcing (figs. 24,E and 25). There was distress in many of the beam-column connections (figs. 26 and 27) where the stirrups or ties did not extend through the joints. Failure occurred in the corner tied columns (figs. 24,E, 28, and 29). Interestingly, the vertical and lateral loads, which caused the collapse of these corner columns, were transferred to the adjacent exterior columns through the cantilever action of the walls above the column (figs. 30 and 31).

Figure 25.—Olive View Hospital, medical treatment and care unit. Distortion of exterior column at first-floor level.

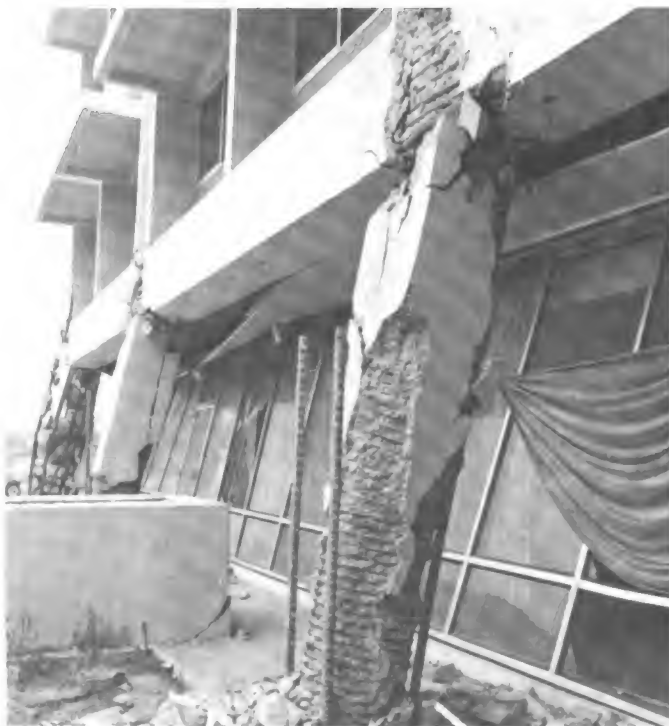
Figure 26.—Olive View Hospital, medical treatment and care unit. Distortion of exterior column at first-floor level.

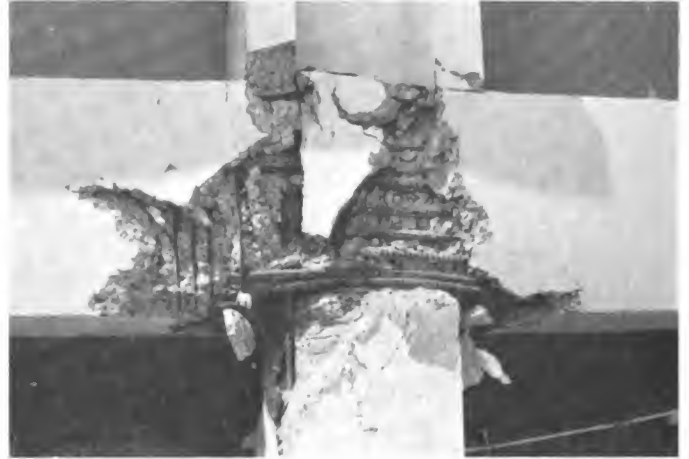
Figure 27.—Olive View Hospital, medical treatment and care unit. Beam-to-column connection detail of figure 26. Note lack of confinement to beam reinforcing bars in this area. Bottom bars also were lapped in this area.

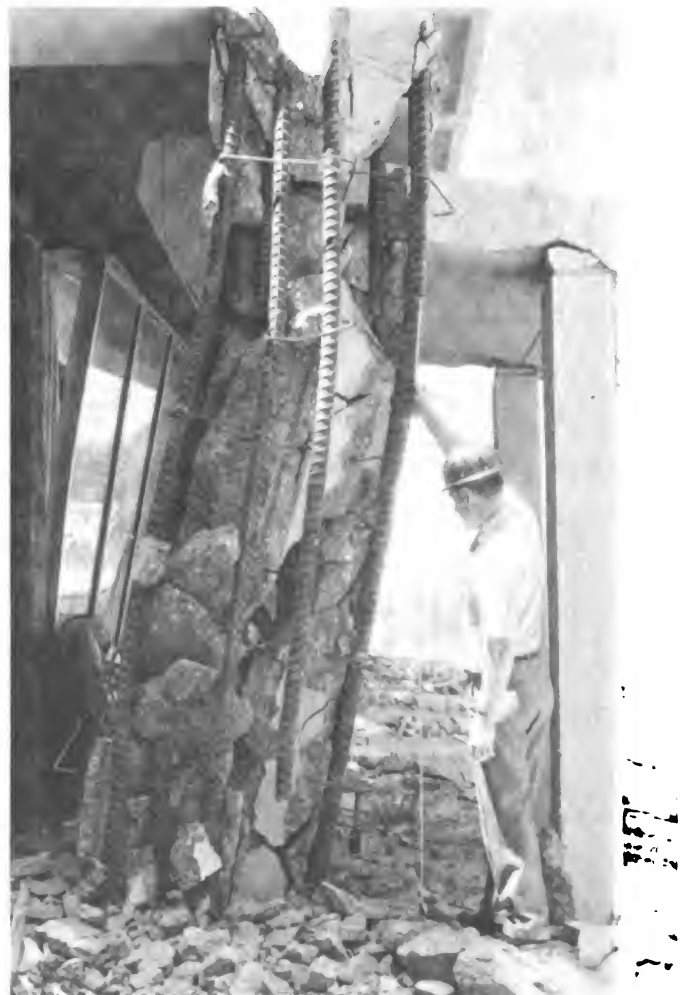
Figure 28.—Olive View Hospital, medical treatment and care unit. Collapse of corner column at first-floor level.

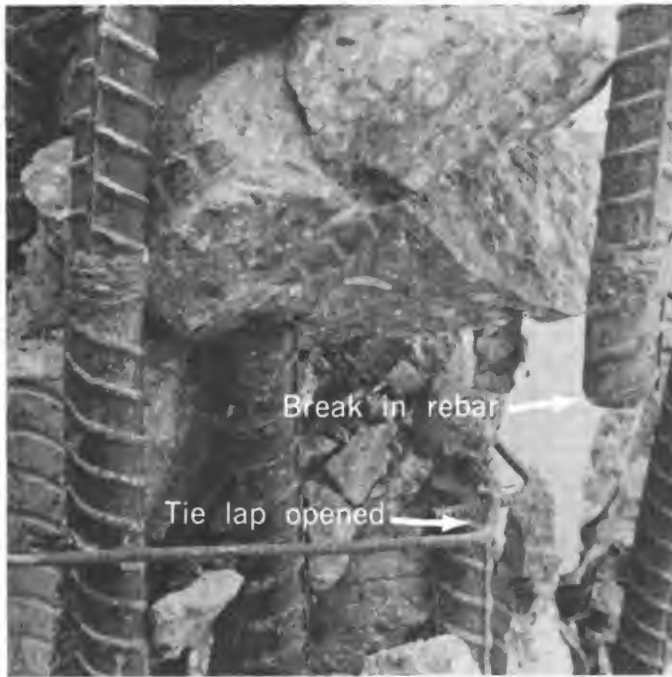
Figure 29.—Olive View Hospital, medical treatment and care unit. Fracture detail of reinforcing bars near a full-penetration butt weld for column in figure 28. Note opening of column tie laps at corner.

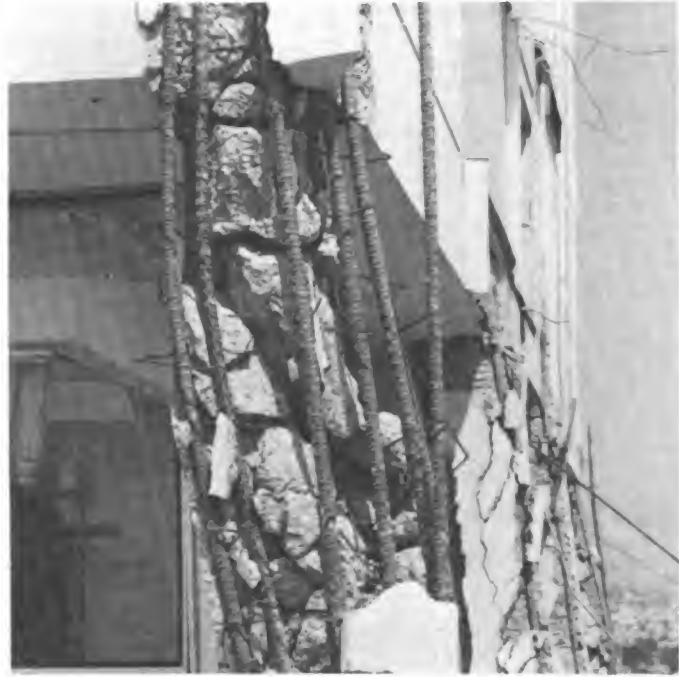
Figure 30.—Olive View Hospital, medical treatment and care unit. View at end of building wing at first-floor level. The wall above probably has carried collapsed corner column load to interior column line. Stair tower is at right of photo.

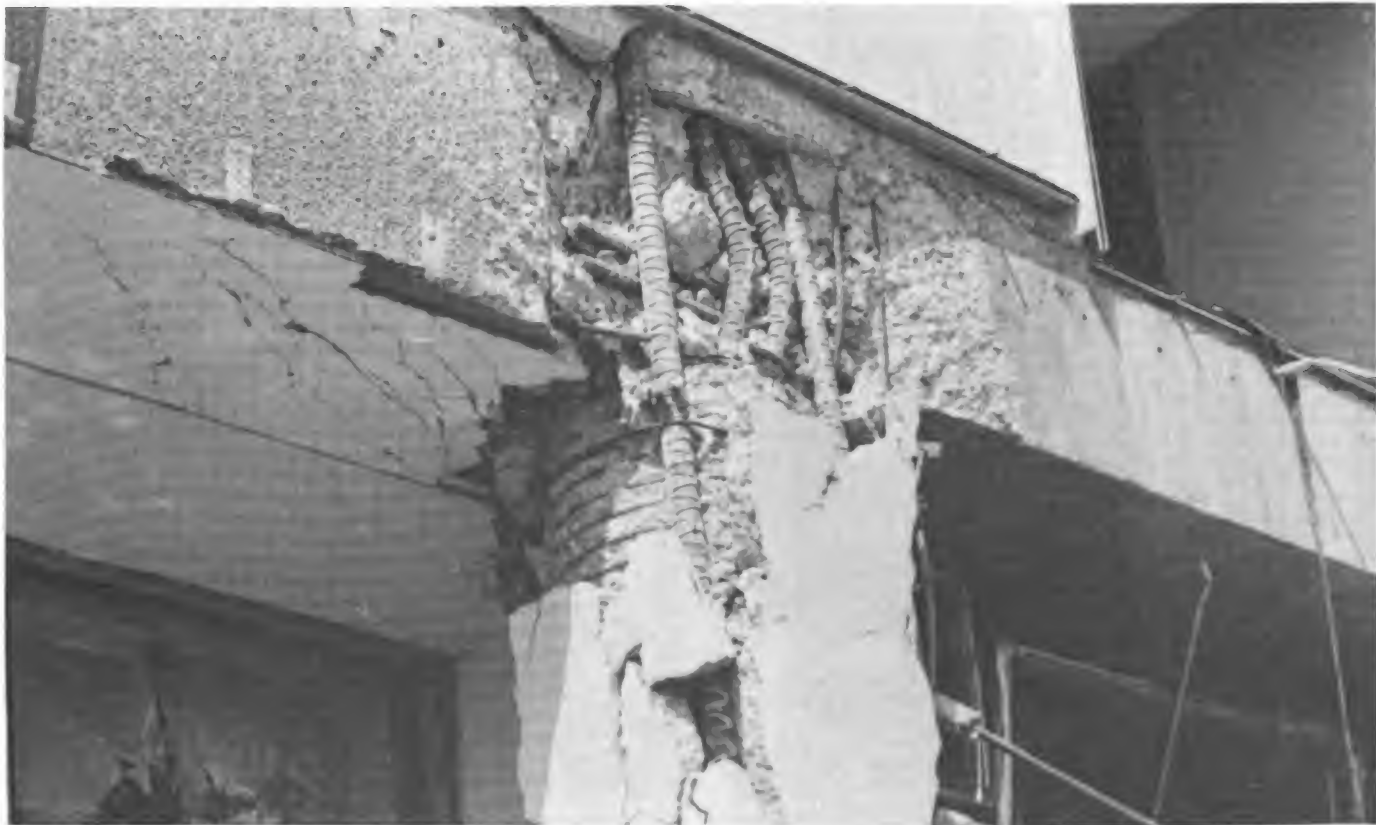
Figure 31.—Olive View Hospital, medical treatment and care unit. Detail view of adjacent column of figure 30, showing distress to connection where confinement was not provided.
